# Final Report

Pinole Creek Fish Passage Improvements Project  
P1530411 00

Prepared for US Army Corps of Engineers  
File Number 2014-00414S

Prepared by  
Sandra Guldman  
Toyon Environmental Consultants, Inc.

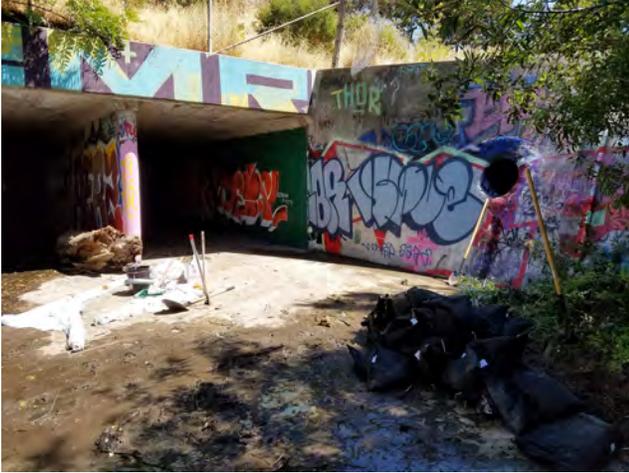
Upstream entrance to box culverts (7/5/16)  
Viewed from left creek bed looking downstream

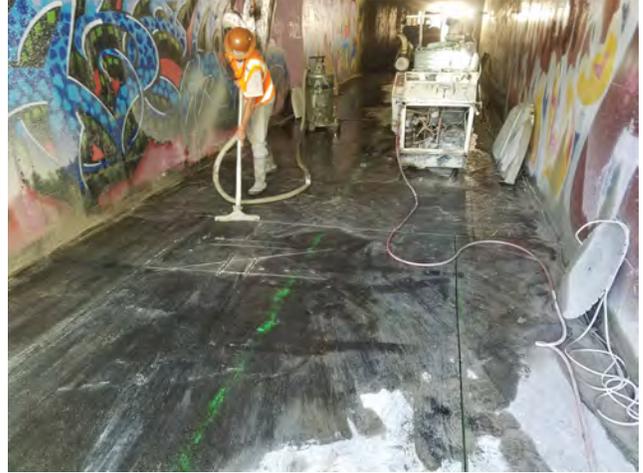
Cleaning up after sawcutting (7/20/16)  
Viewed looking downstream in left culvert

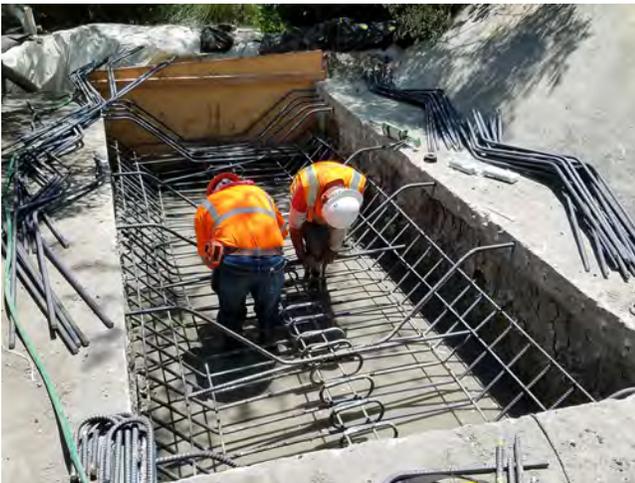
Installation of rebar (7/27/16)  
Viewed looking upstream in left culvert

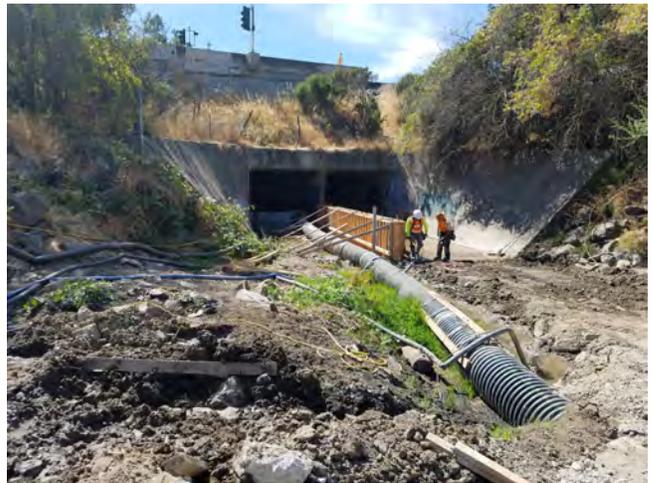
Framing for sidewall (8/29/16)  
Viewed looking upstream

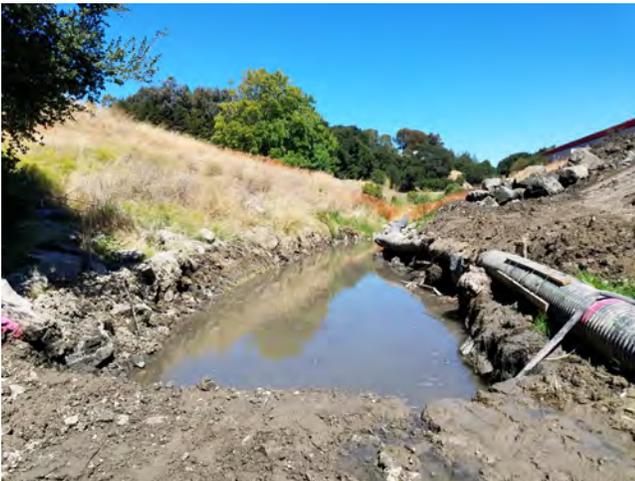
Preparation for rock placement (8/30/16)  
Viewed looking downstream

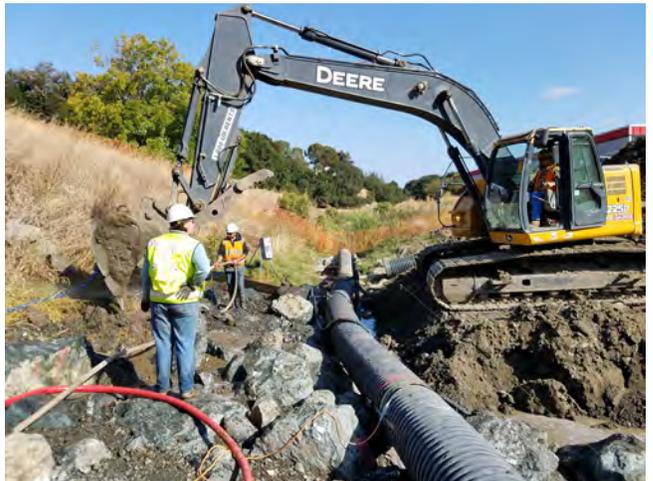
Placement of rock (9/13/16)  
Viewed looking downstream

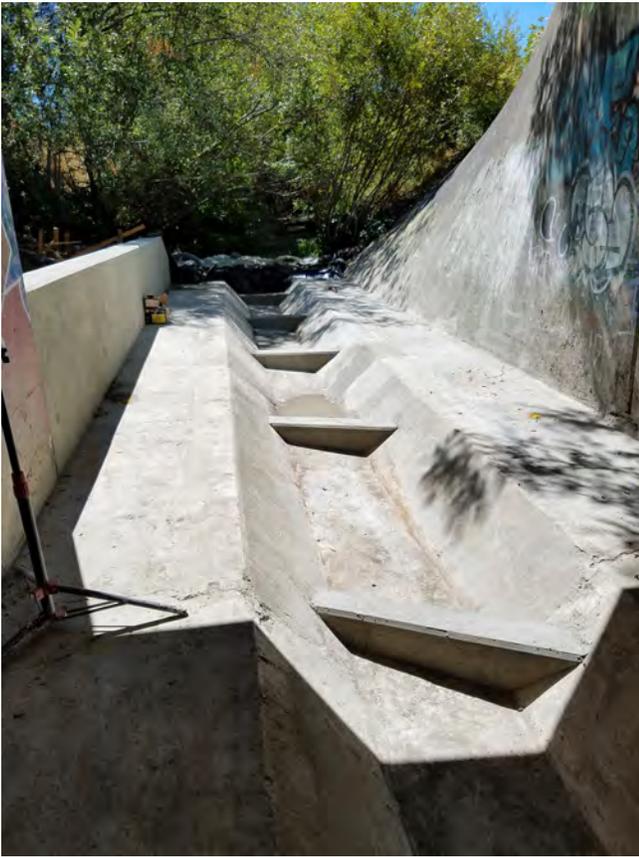
Completed low-flow channel (8/30/16)  
Viewed looking upstream

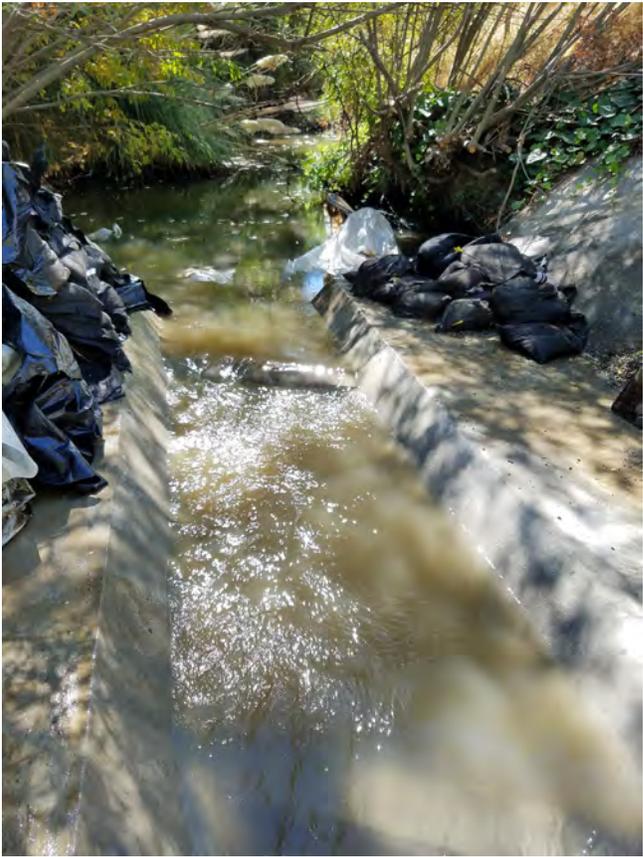
Low-flow channel after removal of cofferdam (9/26/16)  
Viewed looking upstream

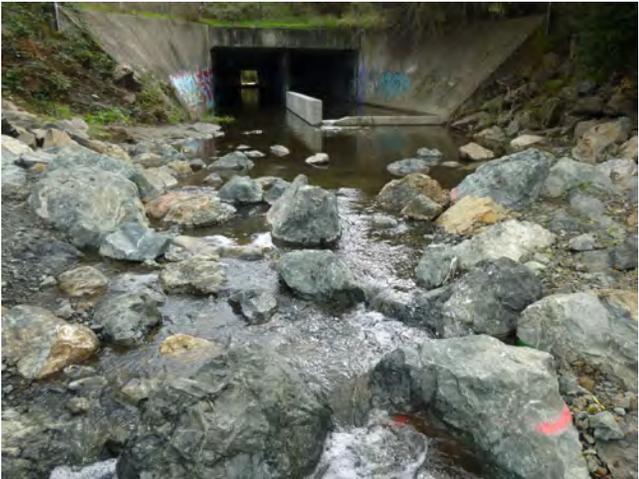
Completed in-stream channel (10/10/16)  
Viewed looking upstream in left culvert

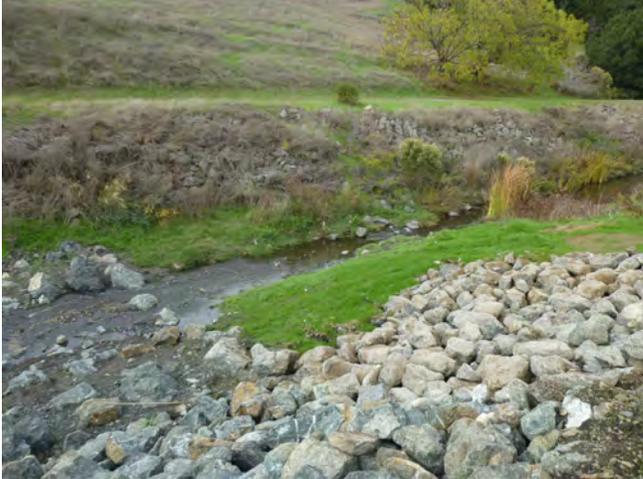
Terminal weir (10/10/16)  
Viewed from right bank

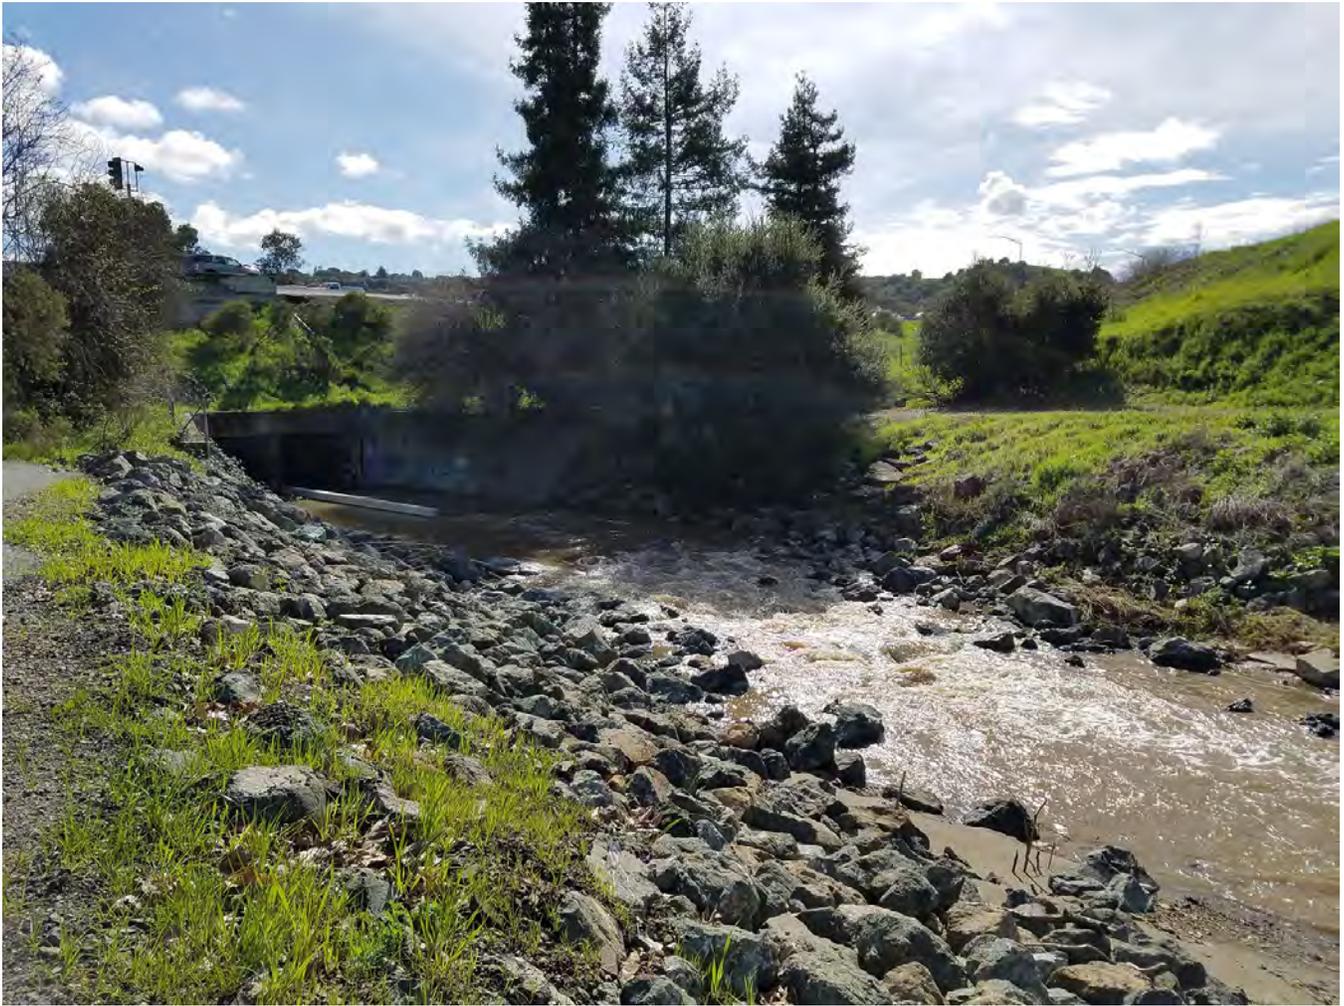
Flow after heavy rainfall (12/5/16)  
Viewed looking upstream from right bank
